## TEMPORARY CORRECTION T-1 TO TECHNICAL MANUAL FOR RADIO RECEIVER R-390A/URR NAVSHIPS 93053

This temporary correction revises the manual to reflect the equipment changes made by Field Change 3-R-390A/URR. The purpose of this field change is to alter the electrical access at the rear of the receiver from terminal strips (TB102, TB103) to "AN" type connectors. If it becomes necessary to remove the receiver from its cabinet, it will be necessary only to unfasten three connectors instead of the individual wires at the terminal strips. The field change applies to all R-390A/URR receivers, all serial numbers.

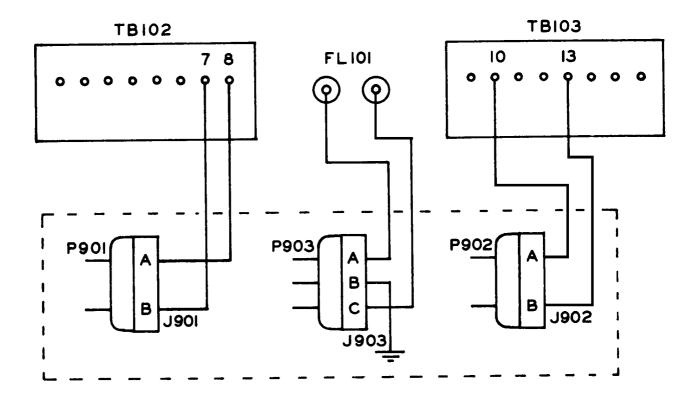
FIGURE I.

The cables are now terminated with "AN" plugs which are connected to the receptacles shown in Figure 1 of this temporary correction.

J901 IS MS3I02AI0SL-4P J902 SAME AS J901 J903 IS MS3I02AI6S-5P

P901 IS MS3108B-10SL-4S P902 SAME AS P901 P903 IS MS3108B-16S-5S

P901-P902 HAVE CABLE CLAMP MS3057-4
P903 HAS CABLE CLAMP MS3057-8

| PAGE<br>NO | PARA & LINE or FIG & LOCATION | ACTION |
|---|---|---|
| 179 | Figure 89<br>(Sheet 2) | Add: "For wiring of connector channel on back panel of receiver, see Figure 1 of this correction. |
| | | It is recommended that Figure 1 be inserted between Figure 89(1) and Figure 89(2). |
