AGC1, 6-18-2007, Moment of Silence switching AGC from Slow to Med. The problem is that C551 has large charge in Slow and when switched to Med, it is discharged causing large negative voltage on AGC line for a second or so. The fix is C590 is kept charged so switching either way causes very little change in potential, thus eliminating the problem.

AGC1A

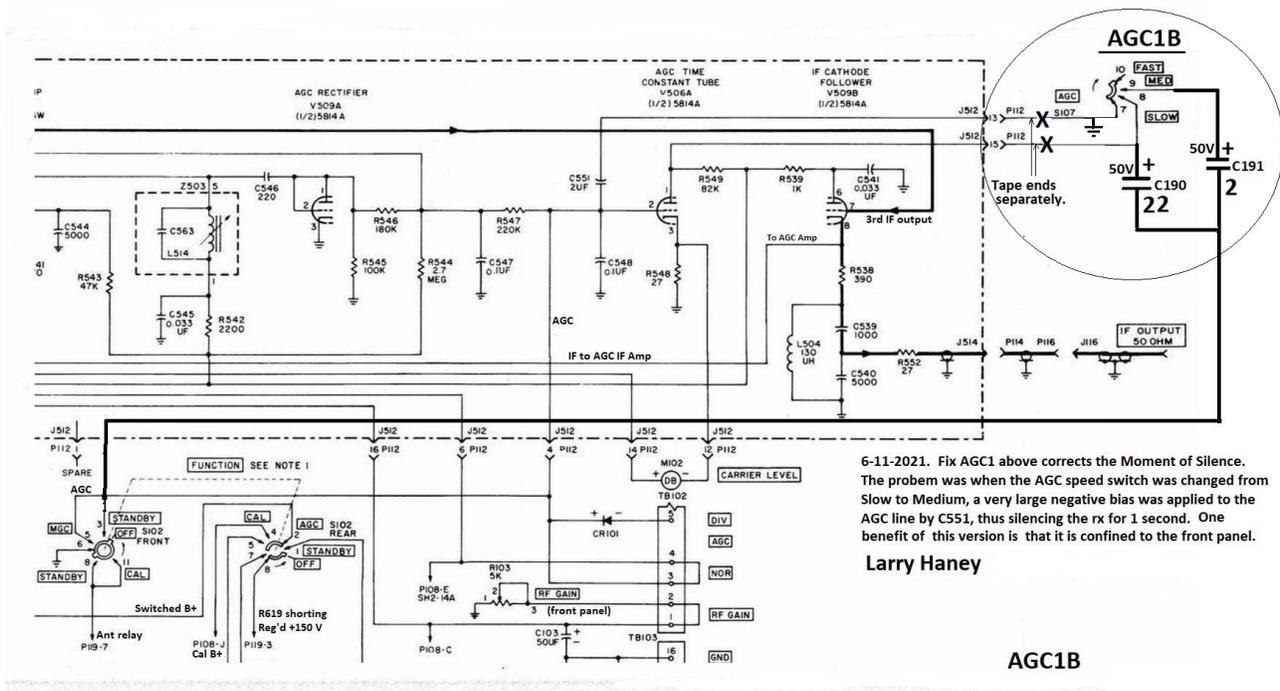
This fix resolves the major and most common issue by setting the voltage level at the Slow and Med switch points to approximately the same value (the B+ line from the plate of V506A is no longer involved). Since the Fast position is open, it is not affected by it, either. I've been using this version since June 2018, and have found it to be very effective on the common issue and improves the other scenarios a little (but they do not happen very often, either). One drawback to this fix is that the front panel needs to be dropped most of the way to install it.

In 2016 I was looking for another better alternative to my original fix I created in 1992. I collaborated with Dave Wise and Charles Steinmetz on the various fixes available. My objective was to still keep it simple and not replace S107 (that was a major consideration). And, the other was to keep it to one area so the modules B+ could still be substituted for testing. I did not want to get into the situation where part of the fix was on the front panel and the rest was on the IF deck. This would tie them together. This is how I came up with the above fix.

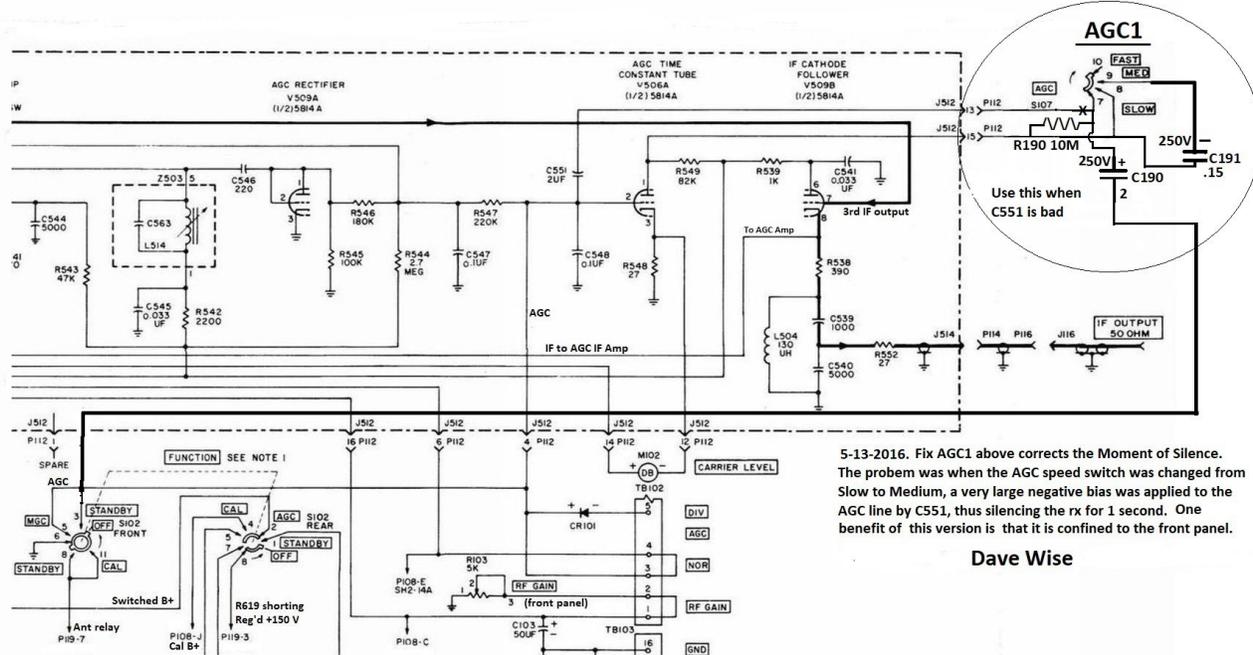
Here's another good candidate by Dave similar to my AGC1B fix:

It has a big advantage in that it uses much lower value caps. You can also add capacitance in the fast position for optimum SSB reception. But, you must put the front panel most of the way down.

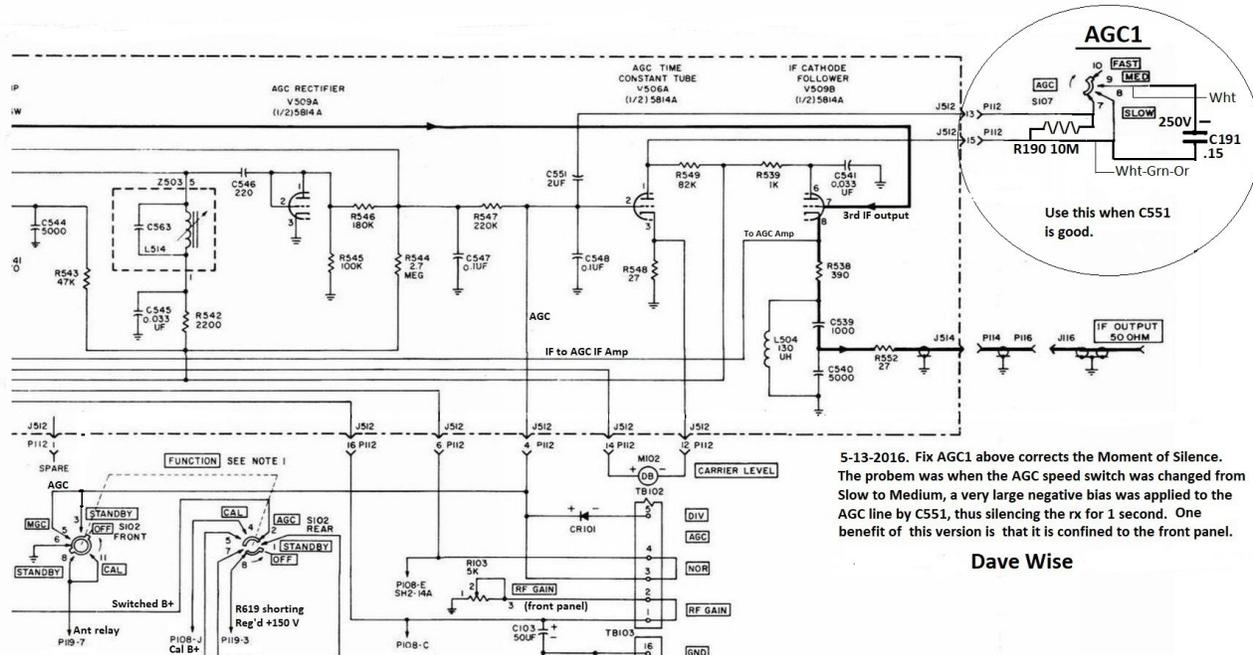
I like this next one by Dave as it requires less wiring changes, uses fewer parts and can be done with the front panel in place (if you're careful). And, if you want to remove it, it's easy to do. It does use the existing C551, so it must be good.

Revision 1: I like this version of the MOS fixes I've seen and am installing it on a 390A. To install the above version, remove the AGC knob and the nut and washer holding the switch in place. Push the switch in a little (about a half an inch) so it can be rotated about 180 degrees so the contacts are facing up for easy access. Be careful of the wiring, although this is easy to do. The following picture shows the white ground wire removed from contact 9 (the AGC medium position) and the 2 components added to the switch contacts. That is the extent of the change.

However, if you use this rx to receive SSB, you may want to add a small capacitance to the Fast position. I've heard that this can improve SSB reception. It should be added to contacts 8 and 10 and should be  $1/13$  the value of the capacitance you want to add. It should be 250 volts or better.

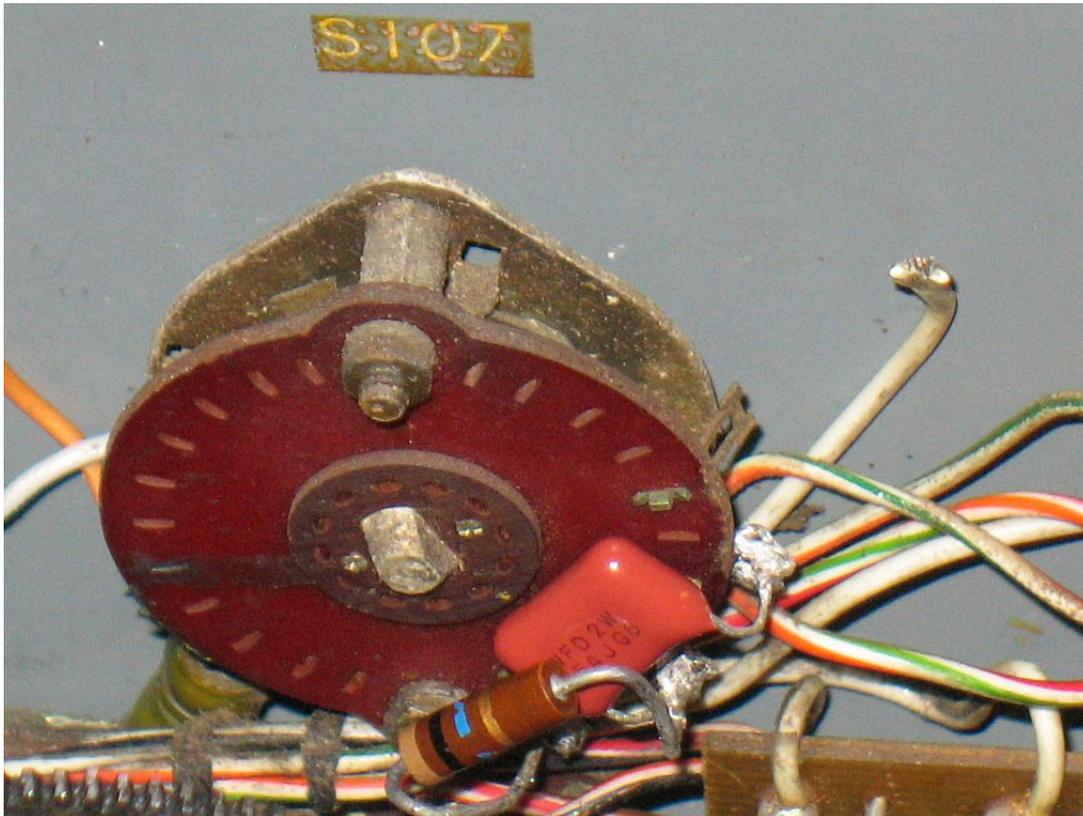
Now, all that is left to do is put the switch back and reinstall the knob. The following picture shows the switch rotated back the way it originally was and with the washer and nut installed to hold it in its original place. It's probably easiest to rotate it in the opposite direction from the way you did it when you made the contacts easy to get at.

Once the installation is complete, a good test to do is set the rx to receive a strong non-fading AM station (register more than 30 db on the Carrier Level meter), wait for a couple minutes and then switch the AGC speed from Med to Slow and back a couple times. The Carrier Level meter should not move at all. If it does, it means that C551 is leaking too much.

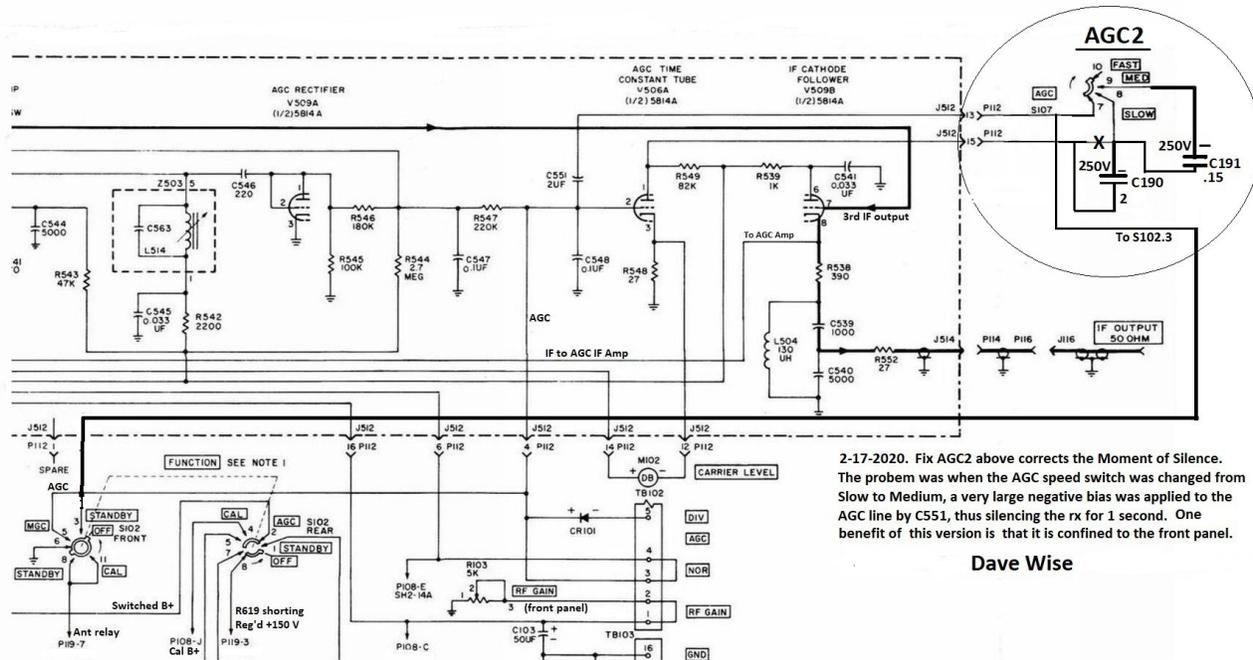
This next version, also by Dave Wise, requires some wiring changes at the switch, uses fewer and smaller parts but can not be done with the front panel in place because access to the Function switch contacts is required. It does not use the existing C551, but it still must not be leaking to ground.
