R-390A 2nd Crystal Oscillator Repair
11-18-2021, Larry Haney

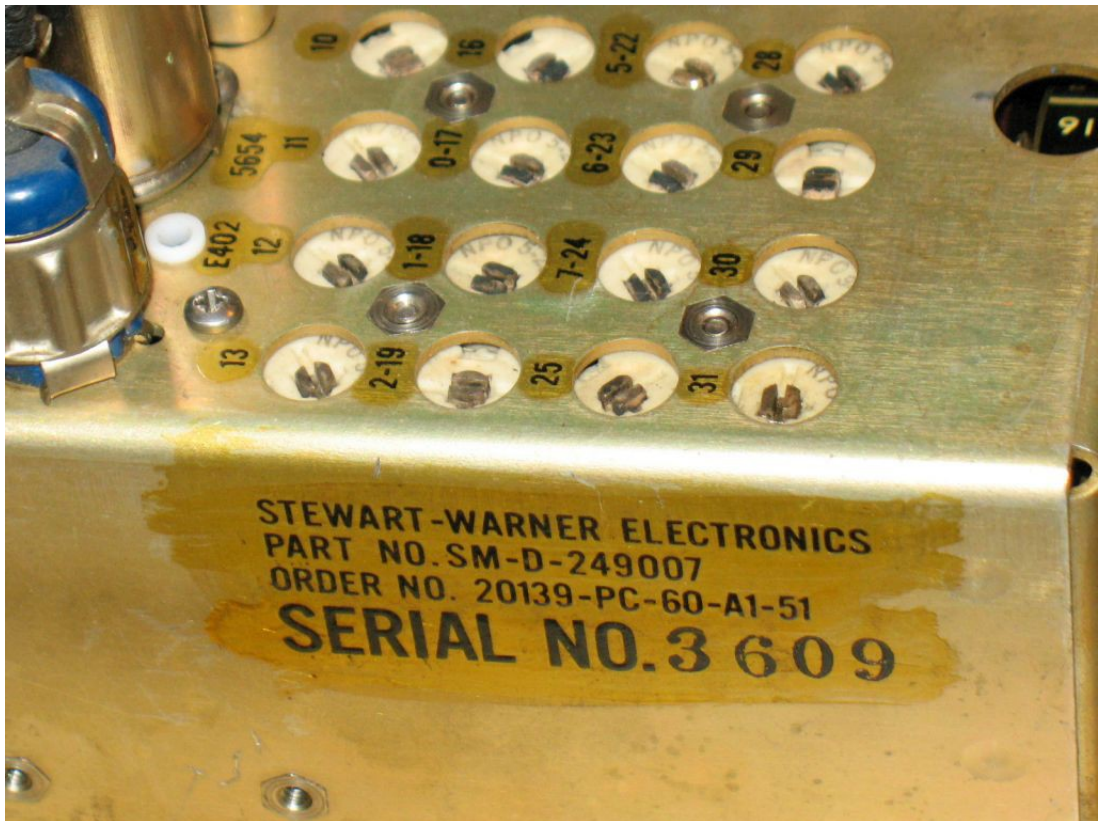
The following picture shows that the trimmers are mounted in the chassis facing up so that dirt and contaminants can easily settle on and around them. Then, when the top of the oscillator deck is cleaned around the trimmers, the dirt and contaminants can easily work their way into the trimmers. If the trimmers adjust easily and smoothly, they may not be the problem. There's only one way to tell – open it up.

The other two items are the trimmer caps and the SM caps in parallel with them. The trimmers can easily get dirty and just need to be cleaned with alcohol. What usually happens to them is contamination reduces their Q. Leakage in the SM caps does the same thing. The SM caps can also change value causing the trimmer to not tune correctly. If the output frequency is not stable on some bands, these two caps are probably the problem.

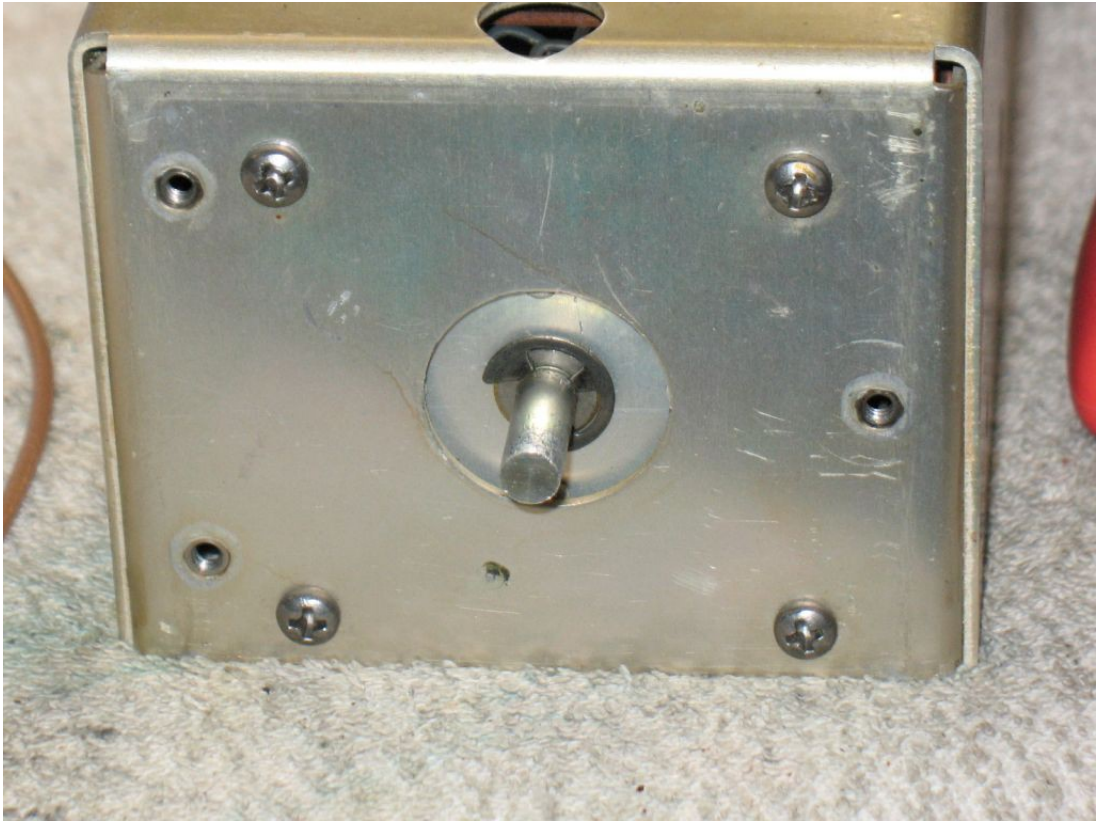
This picture shows the C clip holding the band switch shaft in place. **Carefully** remove it, as it will easily fly across the room. It needs to be removed so the switch shaft can be pulled back to allow the 3 phenolic boards to be raised up on one end.

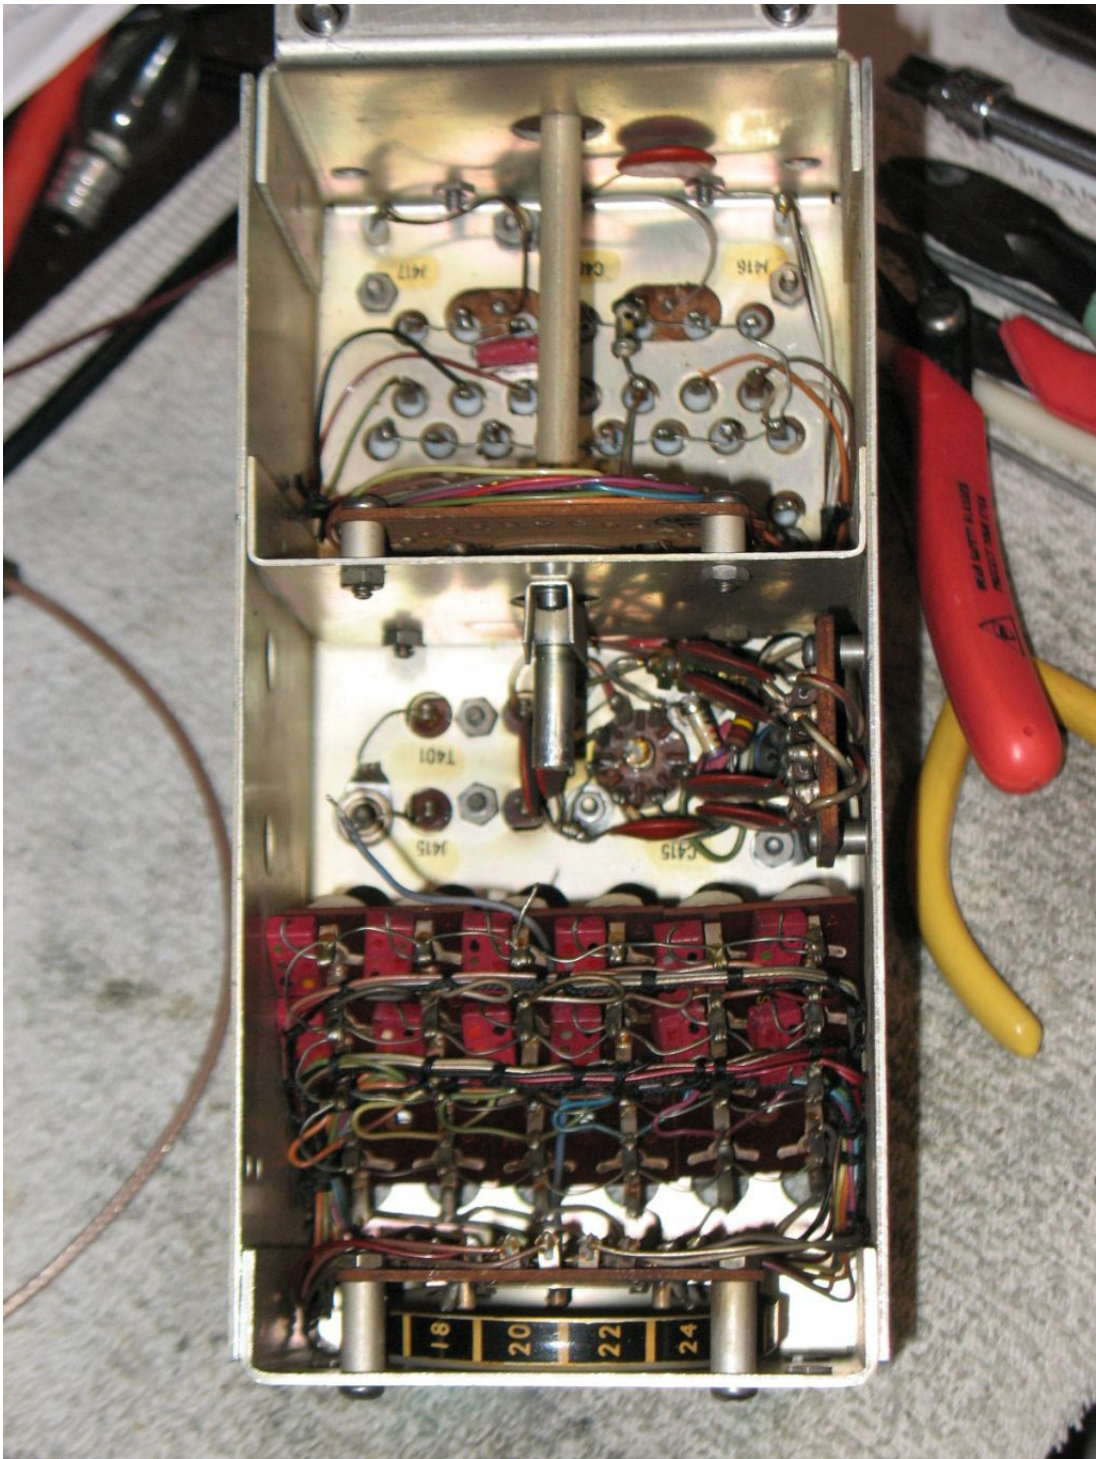
The following picture shows the bottom side of the deck. The band switch shaft has been pulled back out of the way of the trimmer mounting boards and one end of the board raised up a little.

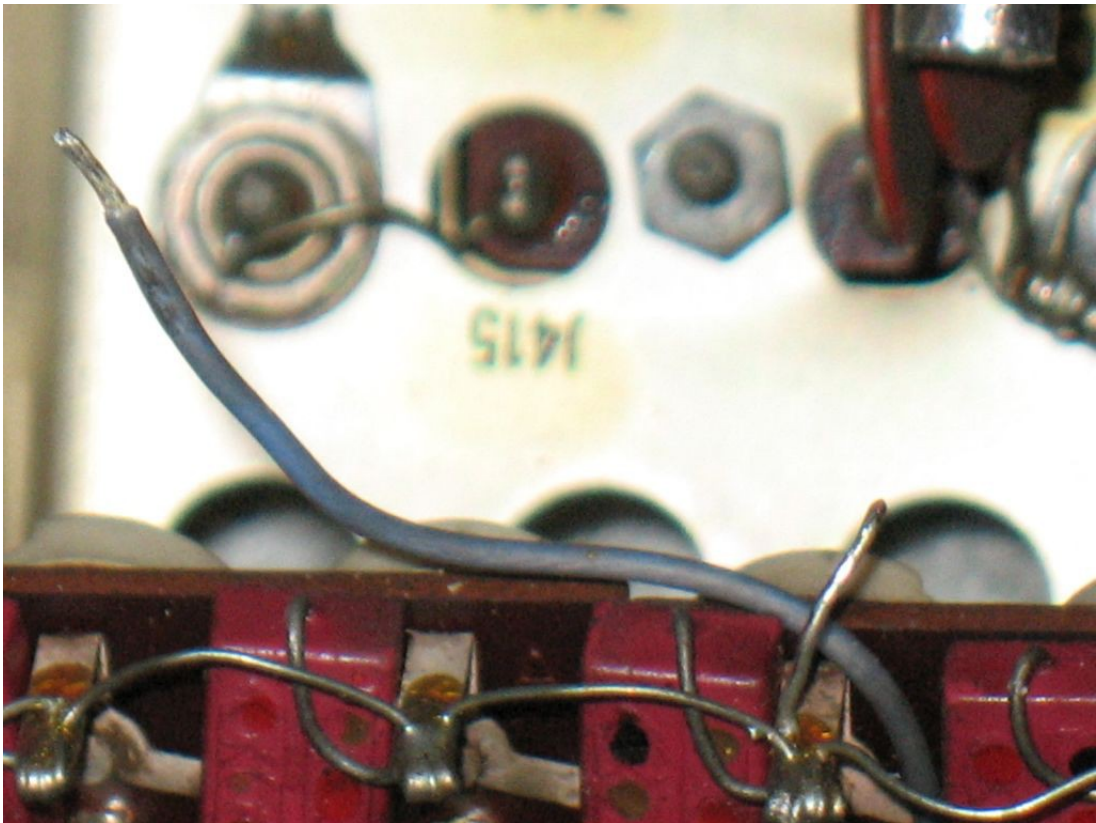
The 3 boards are easy to raise up on one end, once the 2 wires are disconnected as shown in the next picture.

The short uninsulated wire is common and is connected to ground. The gray insulated wire is connected to the plate circuit for tuning. Once these two wires are disconnected, the 3 boards can be raised up on this end (where the 2 wires were disconnected) to expose the other side of the trimmers for cleaning.

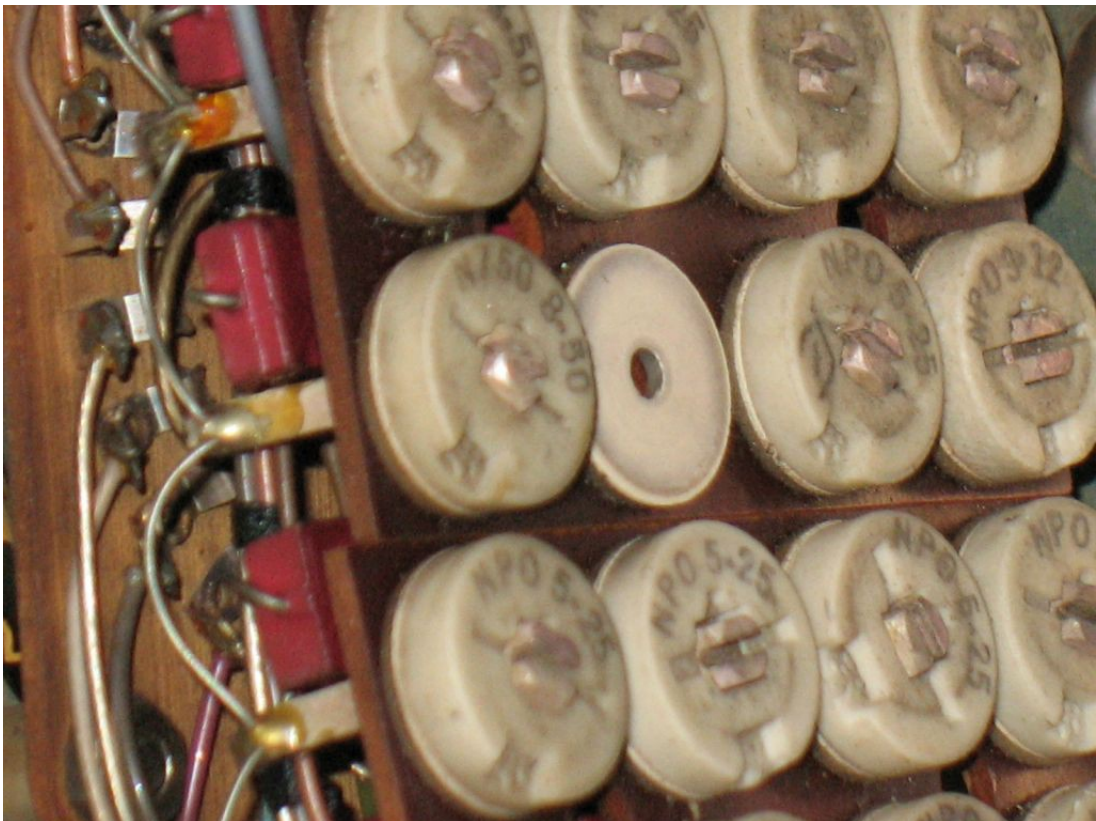
The top of the trimmer comes off fairly easily, as shown above. You can use a screwdriver to carefully push the retaining clip away from the mounting stud on the other side, to release the top half that is the adjustable half. It may fall right out, so be careful not to drop it. Once it's out, you can clean both sides and dry them well (very important) before putting it back together. If cleaning the trimmer did not increase the output enough, then the problem is more than likely the SM cap in parallel with it.
