My R-390A Cosmos PTO Observations
Larry Haney, 3-19-2018
Revision 1, changes A - C, 11-10-2020, Larry Haney

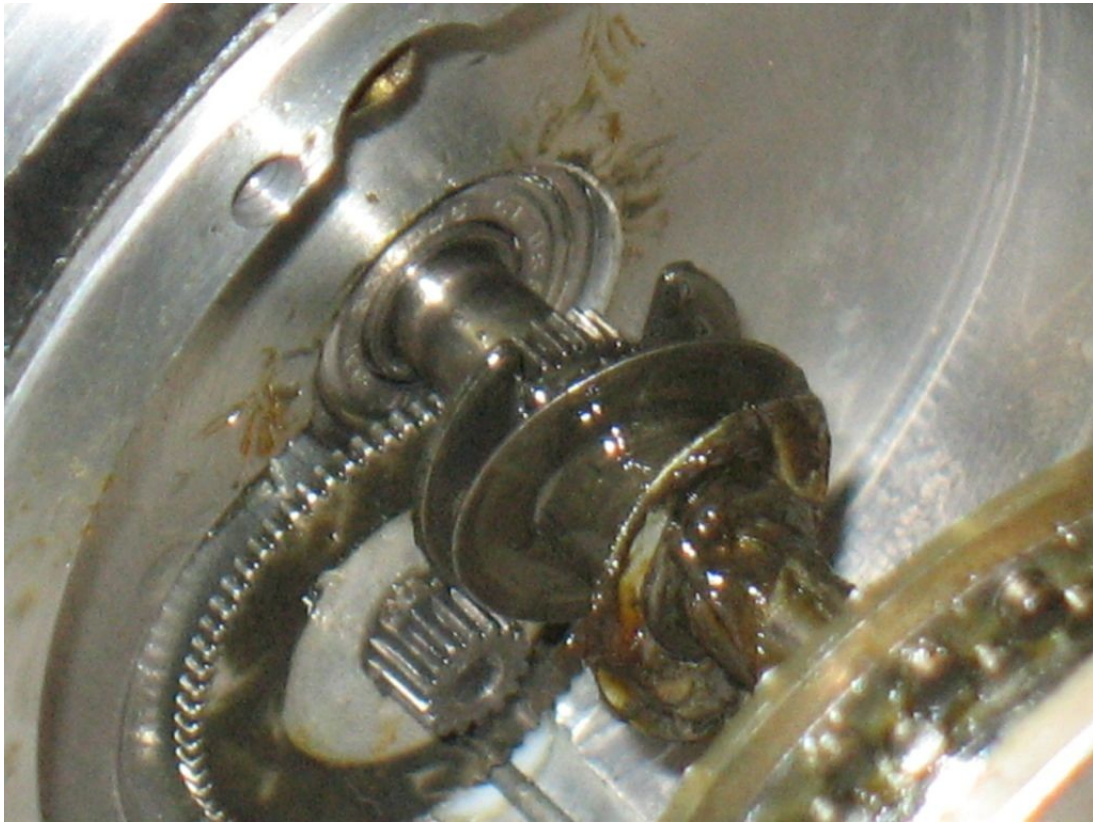
The gears should be lubed vary sparingly with a good medium viscosity synthetic oil with PTFE in it (such as Super Lube). The wavy and flat washers should be lubed with a heavier grease. The number and thickness of the washers there determines how hard the disc is pressed against the bronze bushing. It must be enough to maintain correct operation of the linearity cam, but not too much as to impair rotation of the shaft. This next picture shows the gears, C clip and washers better:

In the above, the shaft has been pulled out a little in order to get a better view. The position of the small reduction gear is not important.

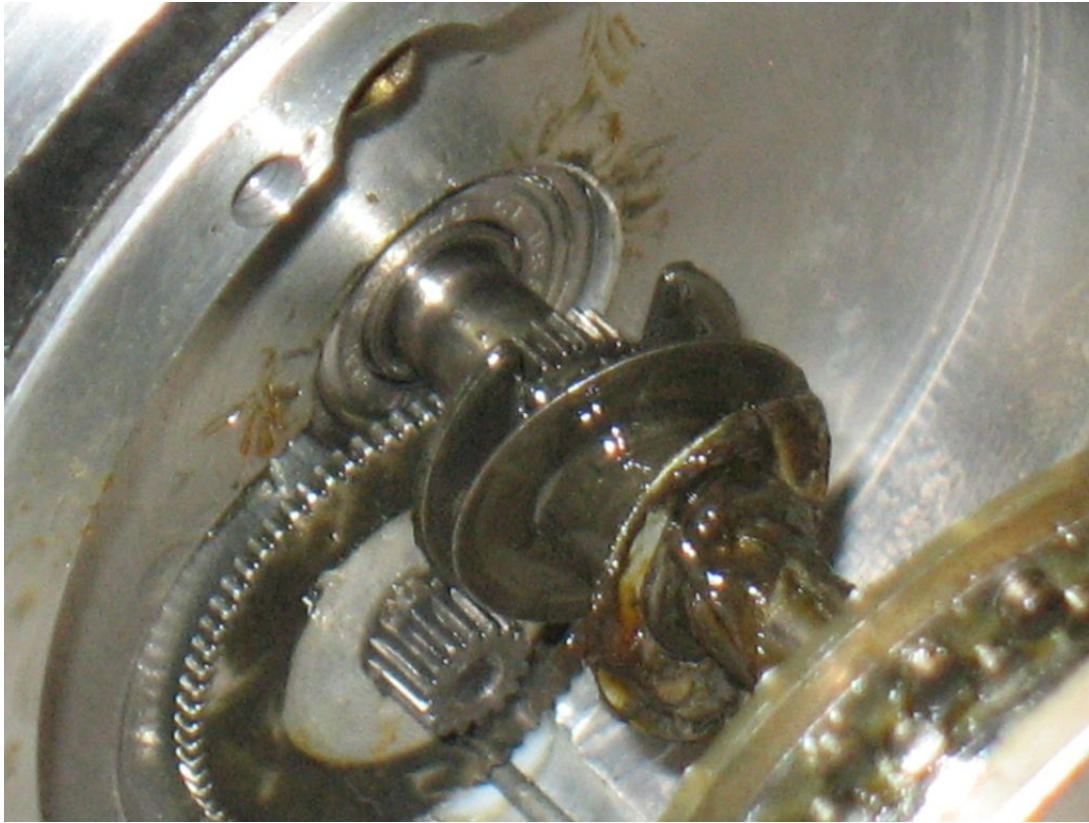
The next picture shows the bearing on the inside:

When reassembling the shaft, make sure that the gears are lined up and the drive gear on the shaft is pushing against the bearing inner racing. Then while holding the shaft against it, press the collar against the other bearing by the outside housing and tighten up the set screws. There should be no end play and the bearings and shaft should still be very easy to turn.
