# Repairing an output transformer from an R-390A

## Repair procedure

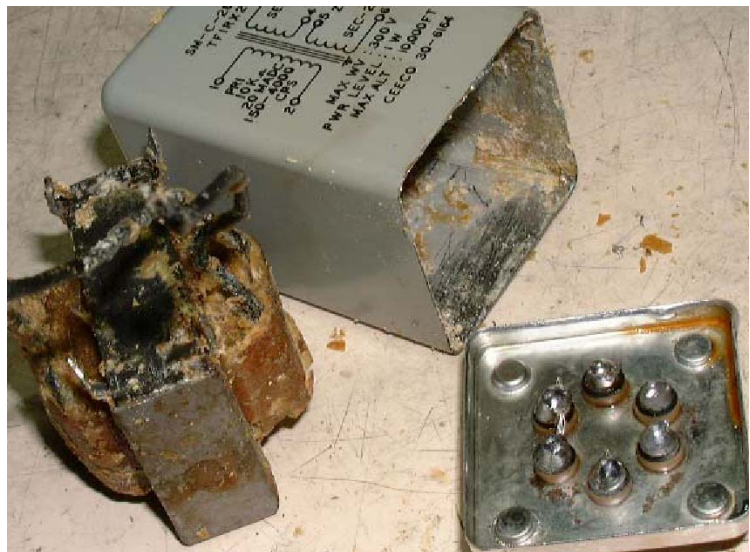
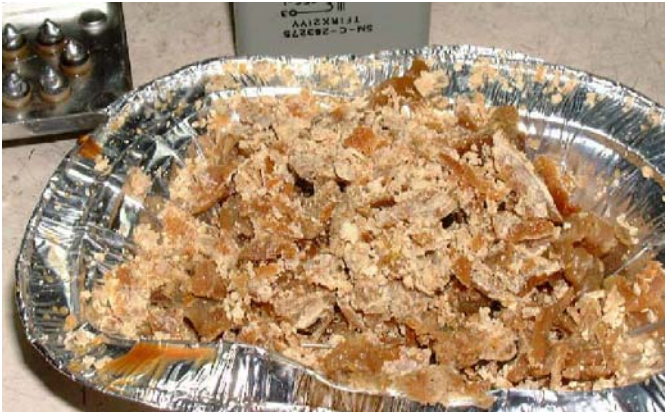
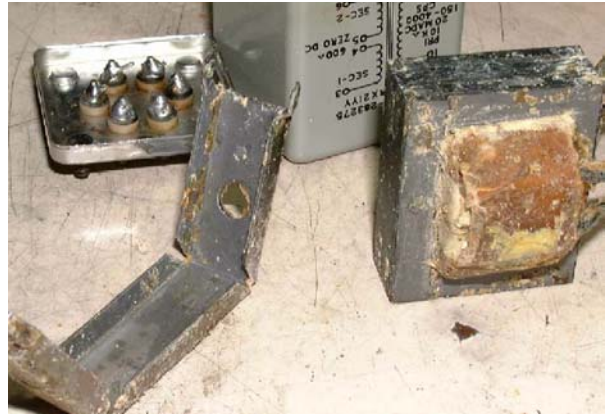
After allowing the assembly to cool, the internal wires were snipped from the feed-through terminals. In order to soften the remaining wax, the can was placed in a small saucepan of water. The water was brought to the boil on the hob and allowed to simmer for a few minutes. Eventually the wax softened sufficiently to allow the transformer to be withdrawn from the can using its lead-out wires. This was achieved by the careful use of two dining forks whilst one of us kept watch for the rightful occupant of the kitchen!

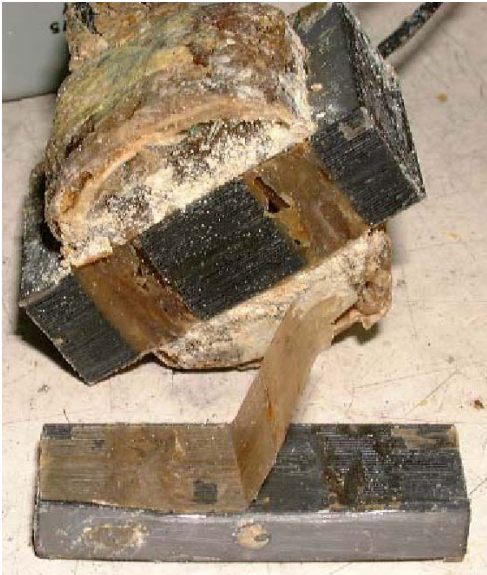
The wax was gently chiseled, using a plastic spatula, from the transformer and the can and was preserved for future use. The transformer turned out to be of conventional E and I construction with a folded steel clamp. I would estimate we recovered ninety percent of the wax. The clamp was opened and the assembly removed.

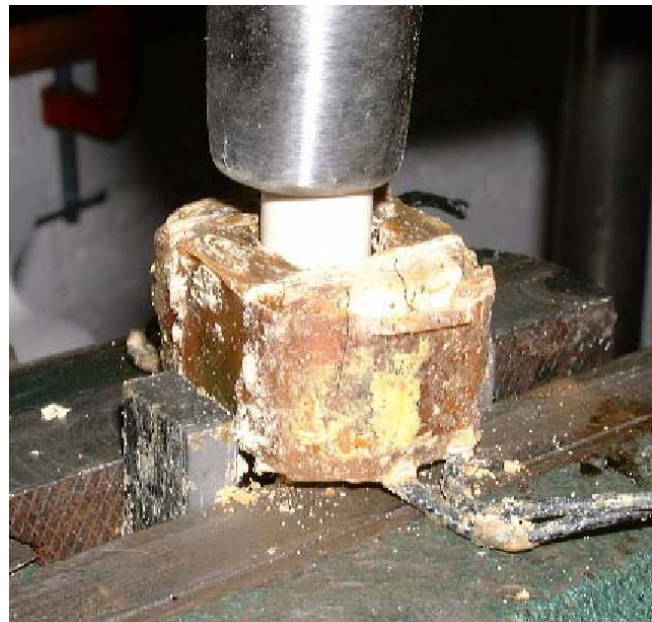
With the clamp removed it was a simple matter to separate the I and E laminations. In the case of a single ended output transformer it is necessary to introduce a small gap into the magnetic circuit. This prevents the net unidirectional current from causing a sufficient flux to allow saturation of the iron during the audio peaks. In this case the gap comprised a two thousandths of an inch paper shim between the E s and the I s. Not interleaving the laminations also effectively introduces a small gap.

You can see here the thin paper shim peeling away from the block of laminations.

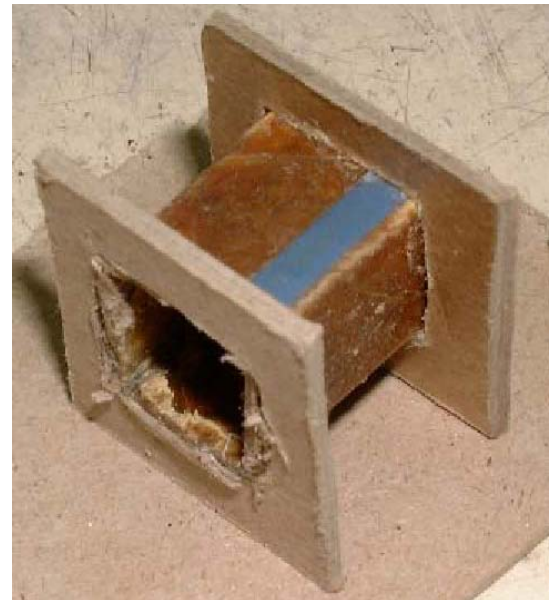
The bobbin assembly was then dismantled. The lead-out wires were secured with cardboard and tape. These were removed first. Then the beginning of the outer winding, one of the secondaries, was located. We needed to count the turns. There were 417 turns on each secondary.

The primary winding was not counted. It was not practical to do this because there are thousands of turns, and the winding was rotten in several places. The original construction utilised a 0.002" paper insulator between each layer of primary winding.

The bobbin was a simple square waxed card cylinder with no end cheeks. It was felt that some temporary cheeks should be fabricated in order to provide lateral support for the windings. Once they were secured with tape and varnish, the cheeks would be removed.

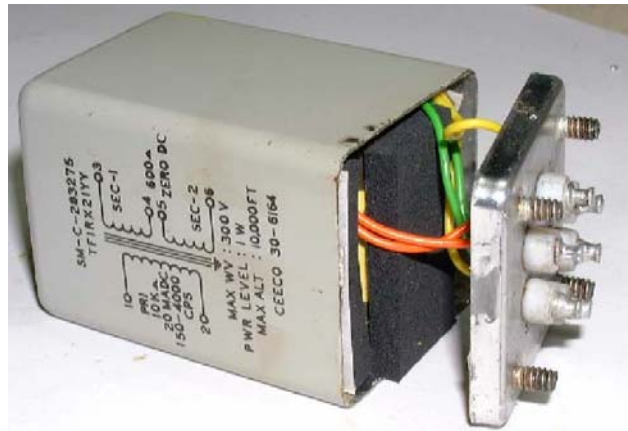
We decided not to re-solder the base. It is a very tight push fit. I am considering the use of an adhesive. If in the future I acquire spools of wire of a closer gauge, I might pull it down and rewind it.

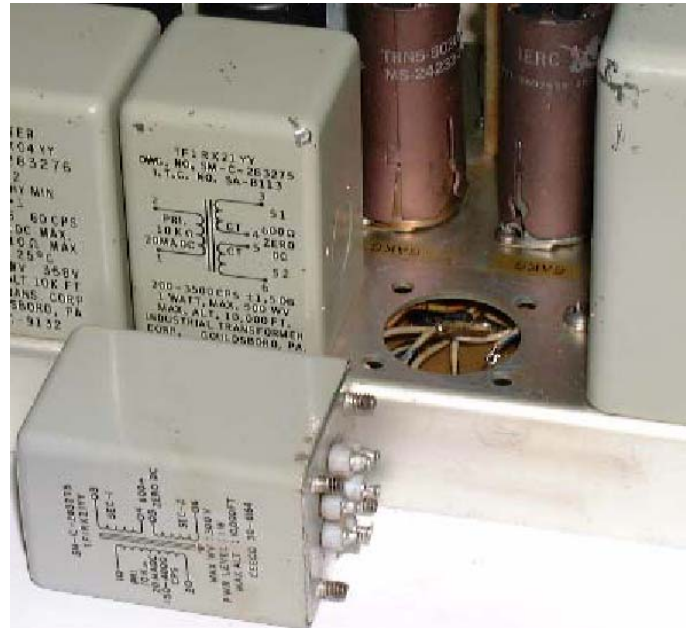
Here is the assembled transformer ready to fit..

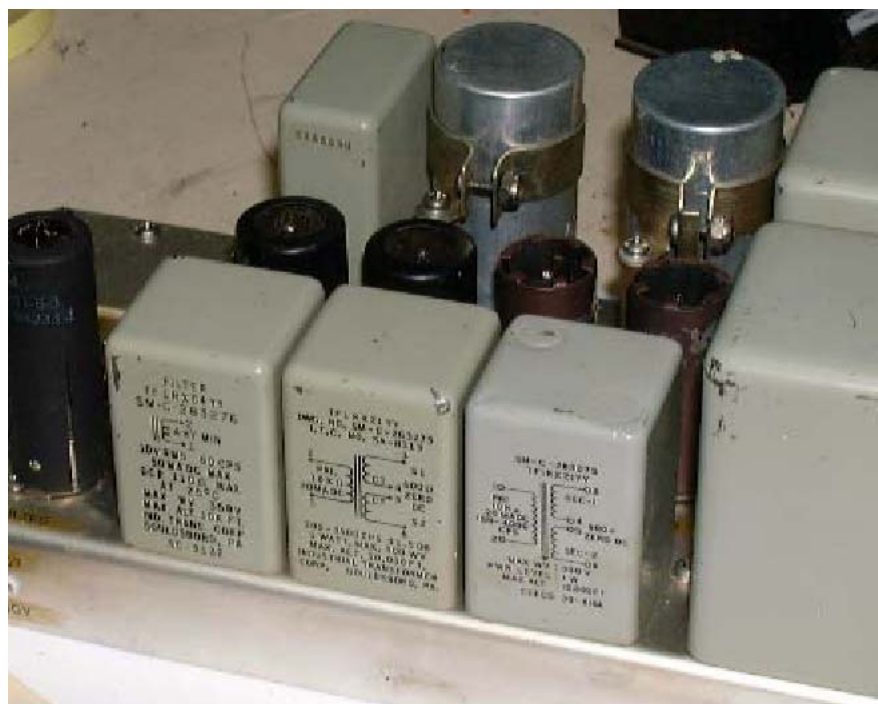
Here it is in place. Not a perfect match but it is very close and I am extremely pleased with it. Thank you John and Steve!
